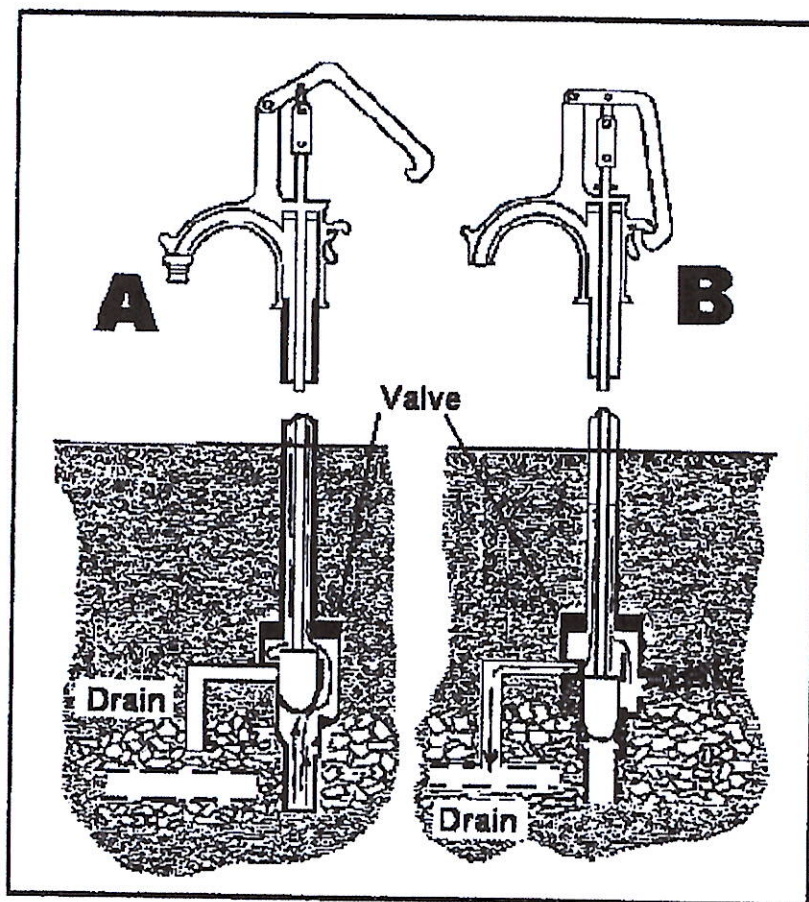
Because the drain port is open when the hydrant is in the off position, it provides **a convenient route through which impure groundwater, insects and dirt can enter the hydrant**, thereby contaminating the water supply. Regardless of whether the hydrant is in the on or off position, contamination of the hydrant and water distribution system is possible under a variety of circumstances.

- First, the valve, which has the dual function of regulating both the water line inlet and the drain port, may leak or become poorly seated. This situation is particularly likely under prolonged use, following repairs, or when the valve rod is poorly adjusted. Mineral deposits and foreign materials or debris in the water may eventually cause the valve to seat poorly. Any valve of this nature, without regular inspection, may leak and is not equivalent to a complete physical break.

- Second, contaminated water or material in and around the hydrant drain can enter the hydrant and distribution system past the leaking valve. This can occur whenever pressure of the polluted source exceeds the pressure in the distribution system. Such back-siphonage or backflow can be produced by a variety of circumstances such as
